PRELIMINARY ASSESSMENT

ARMY RESERVE CENTER
PEWAUKEE, WISCONSIN

REPORT DOCUMENT NO.
SFIM-AEC-IR-CR-93129

January 14, 1994

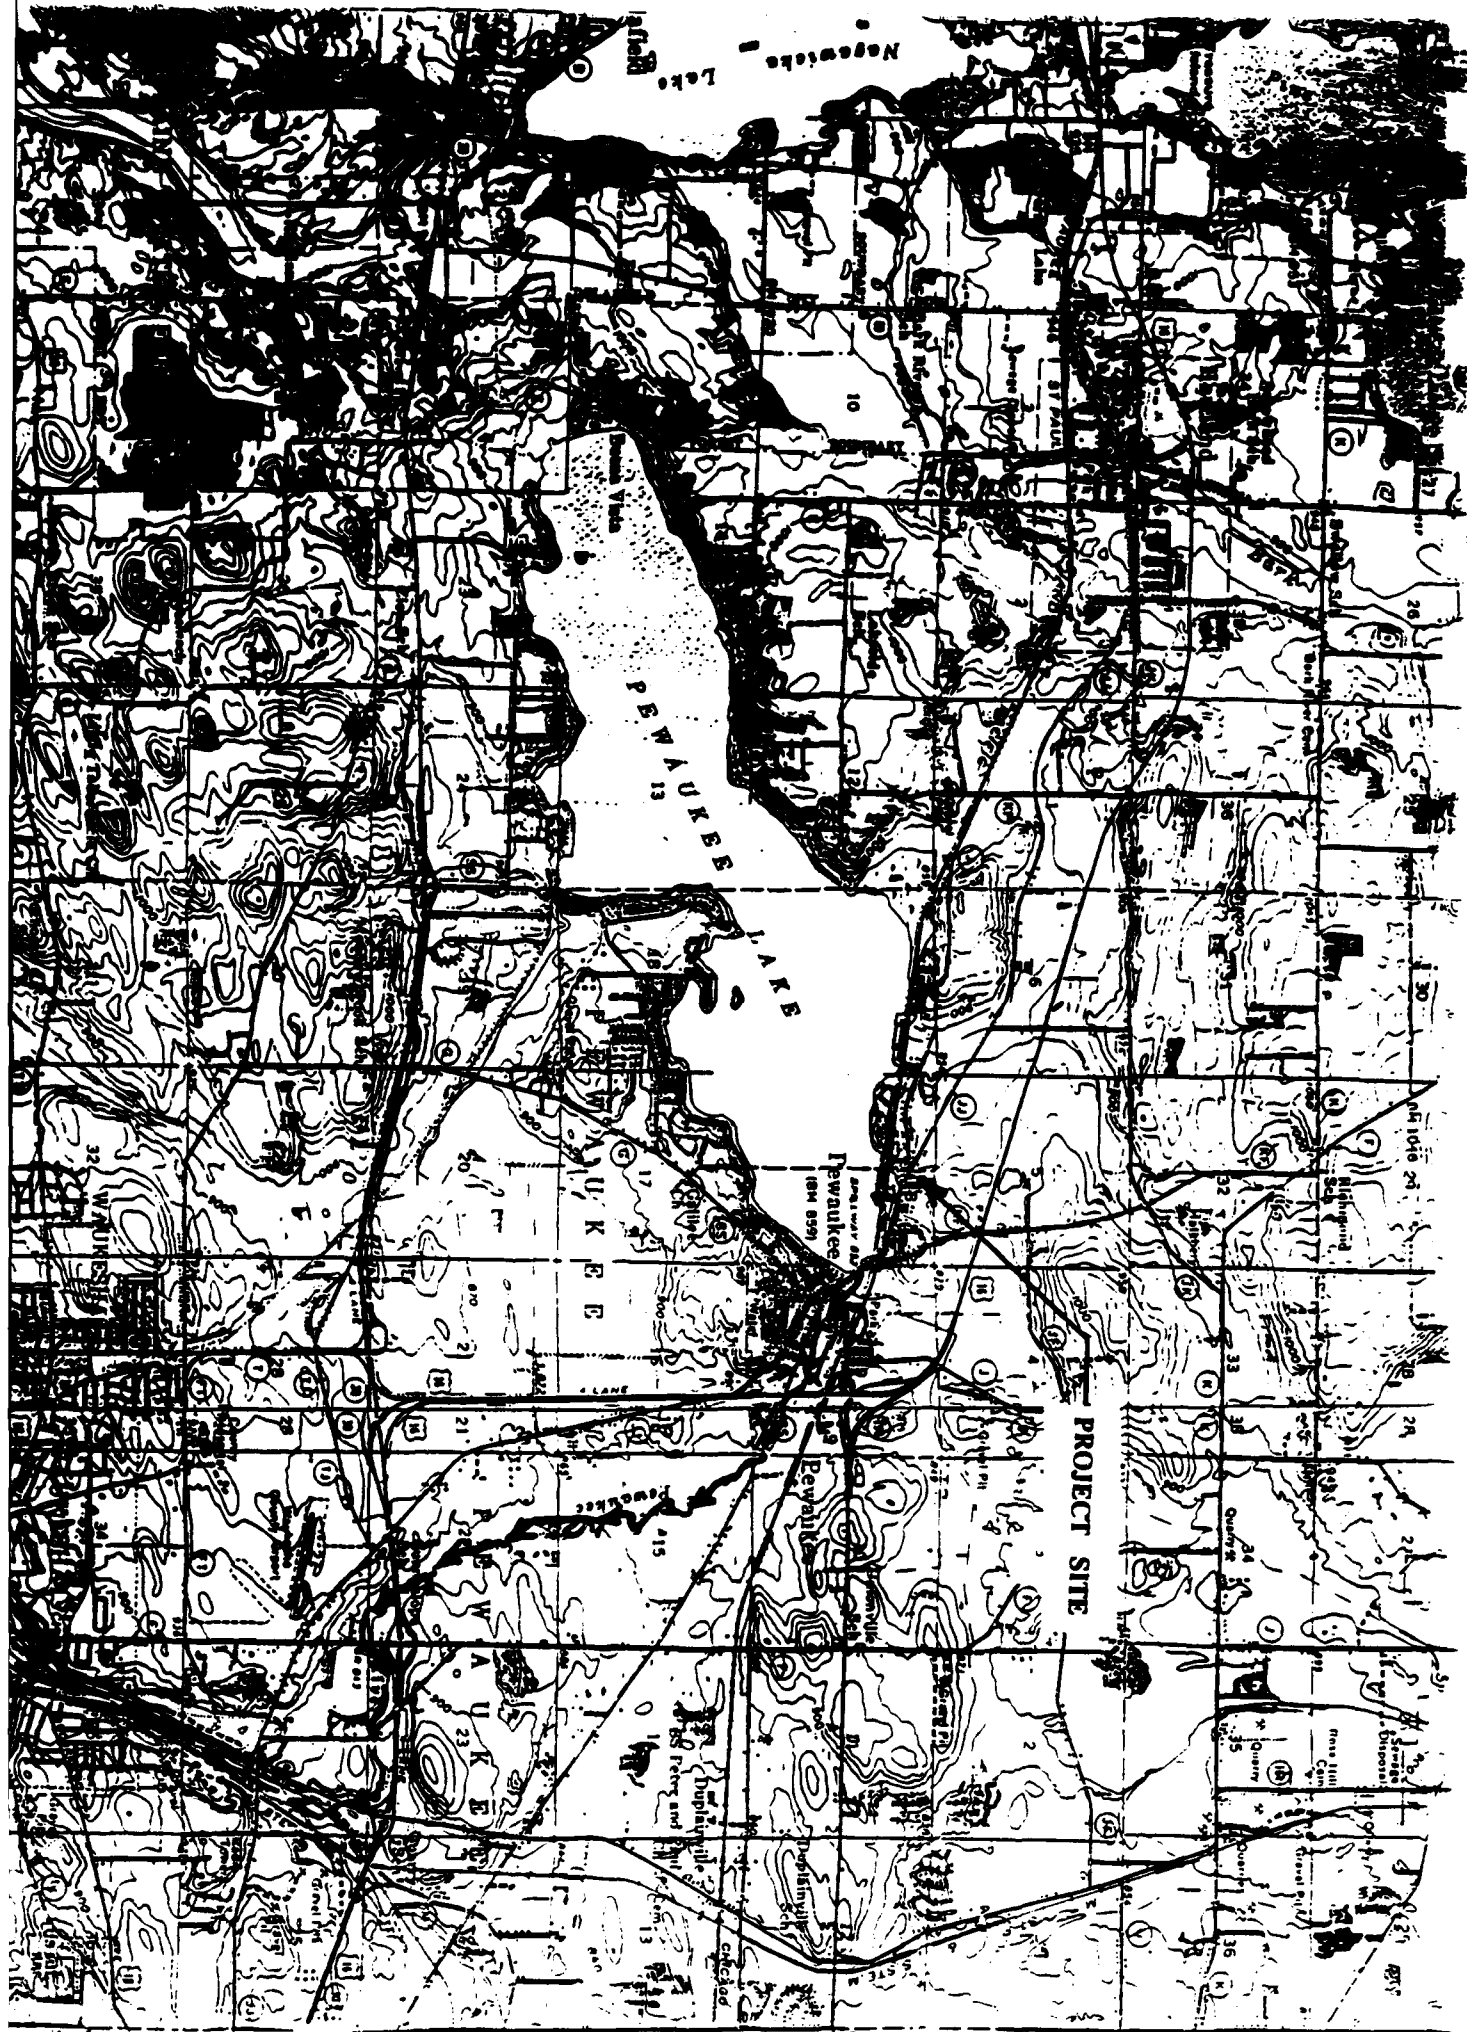
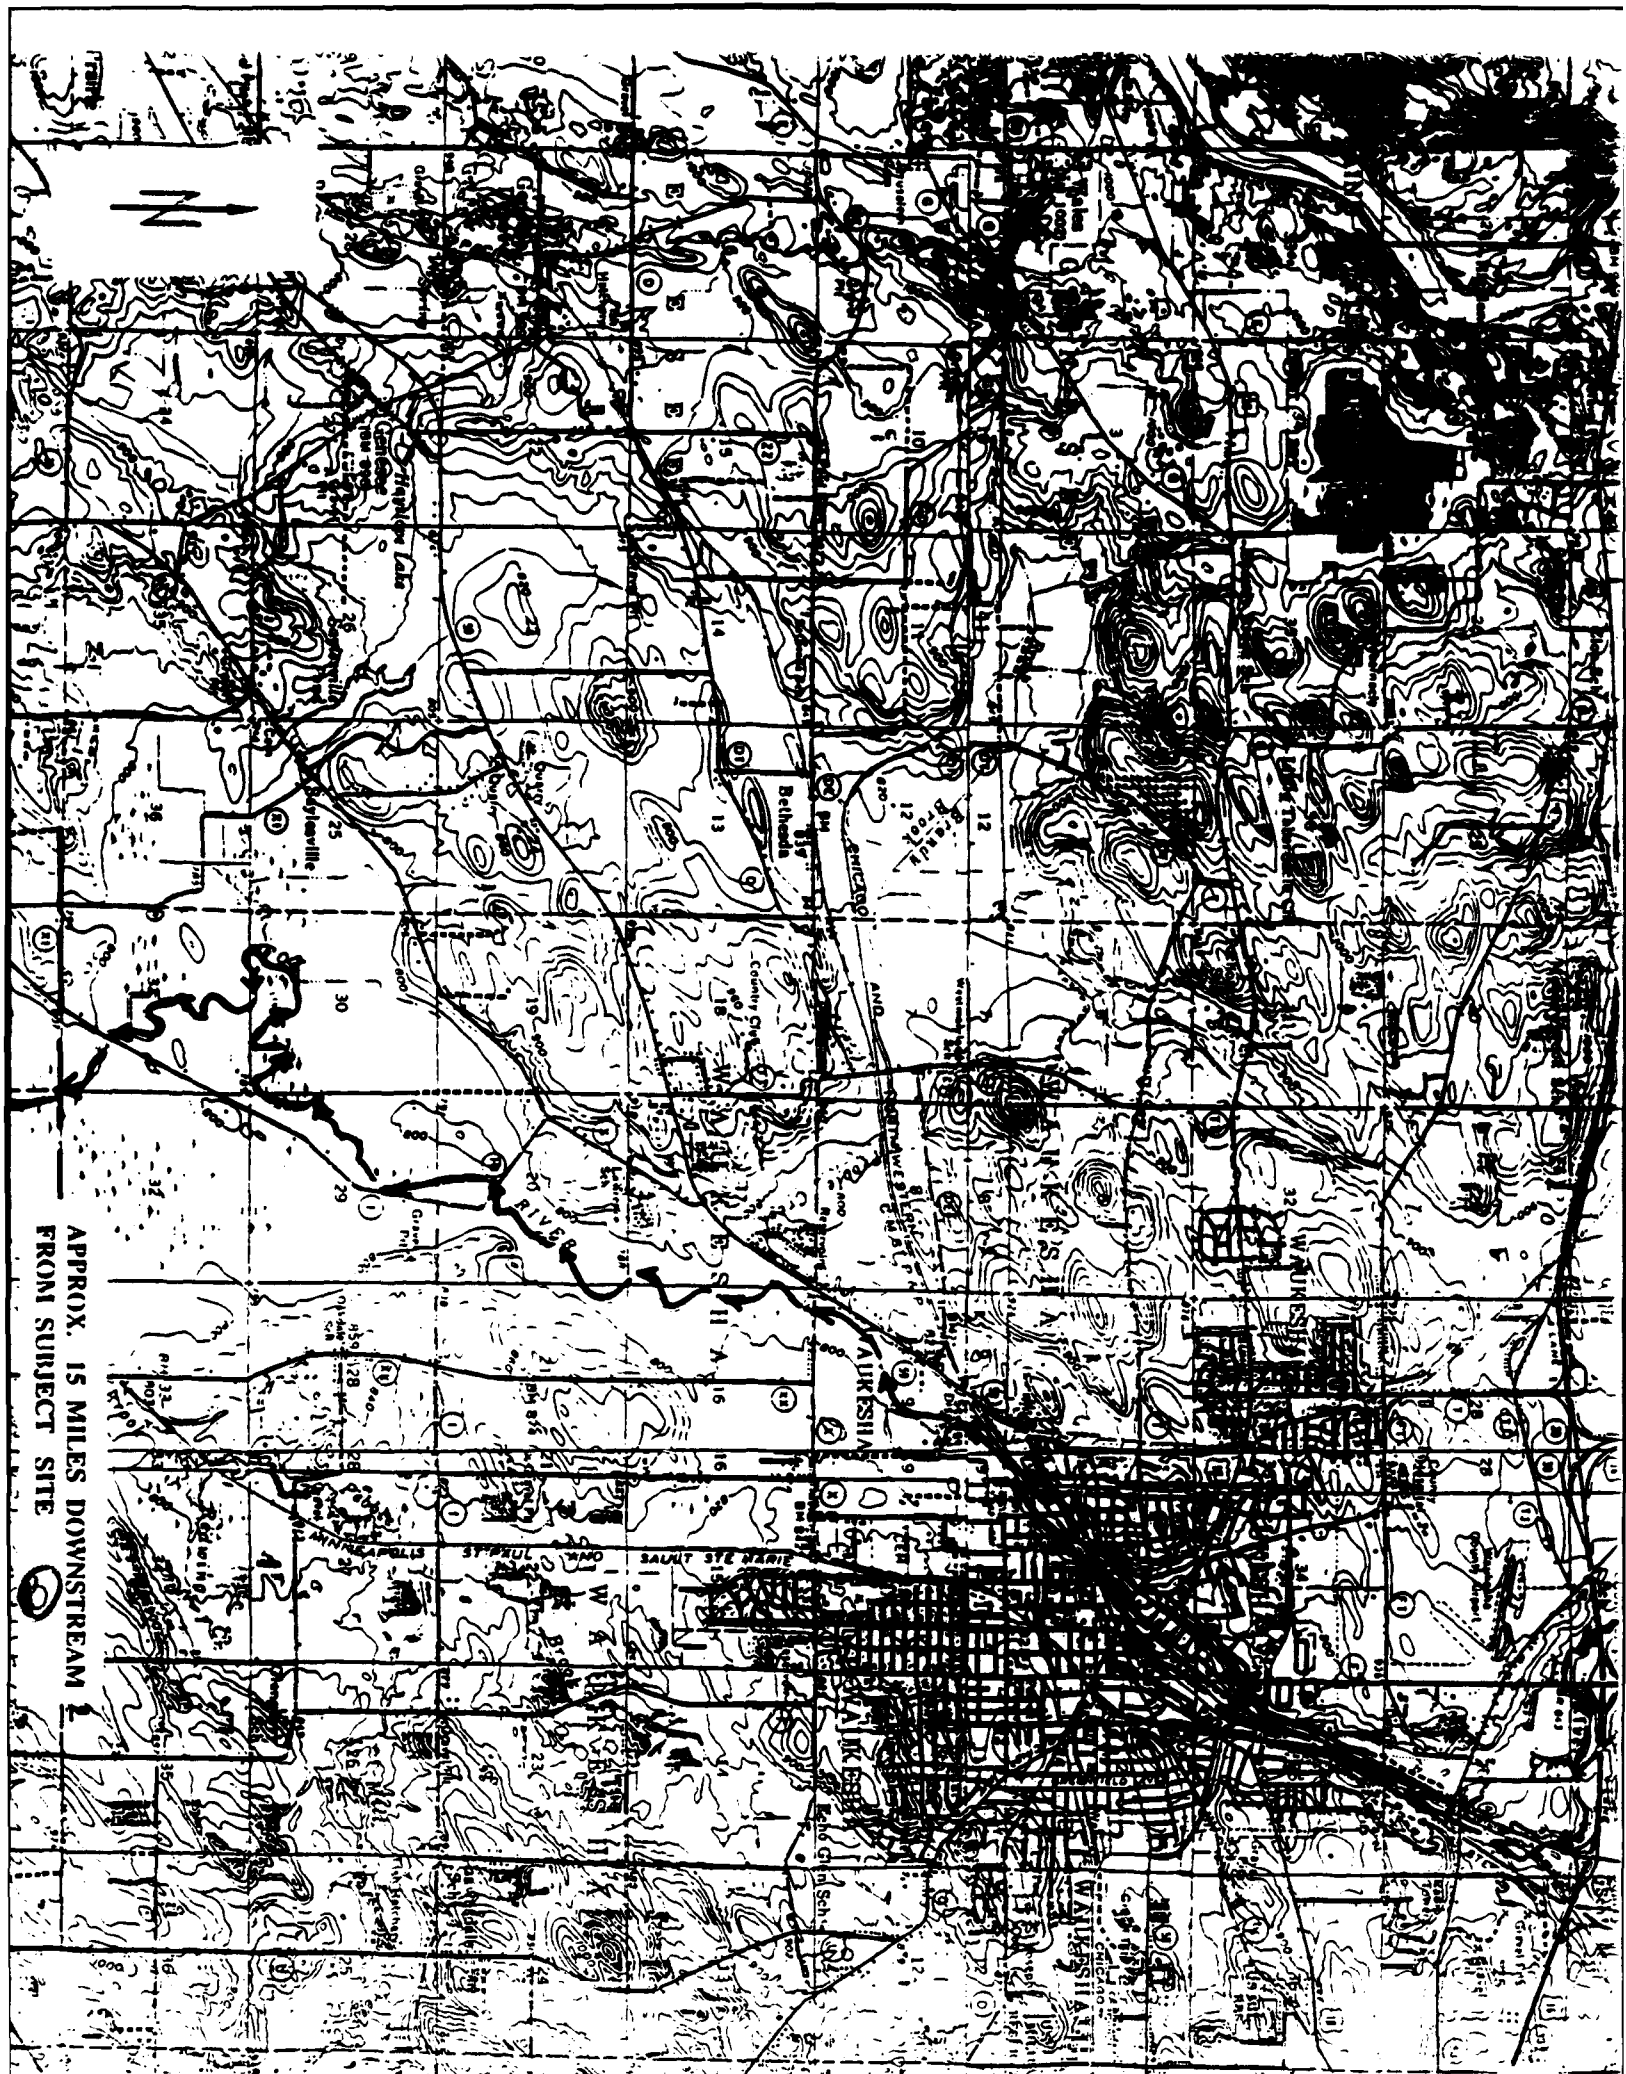
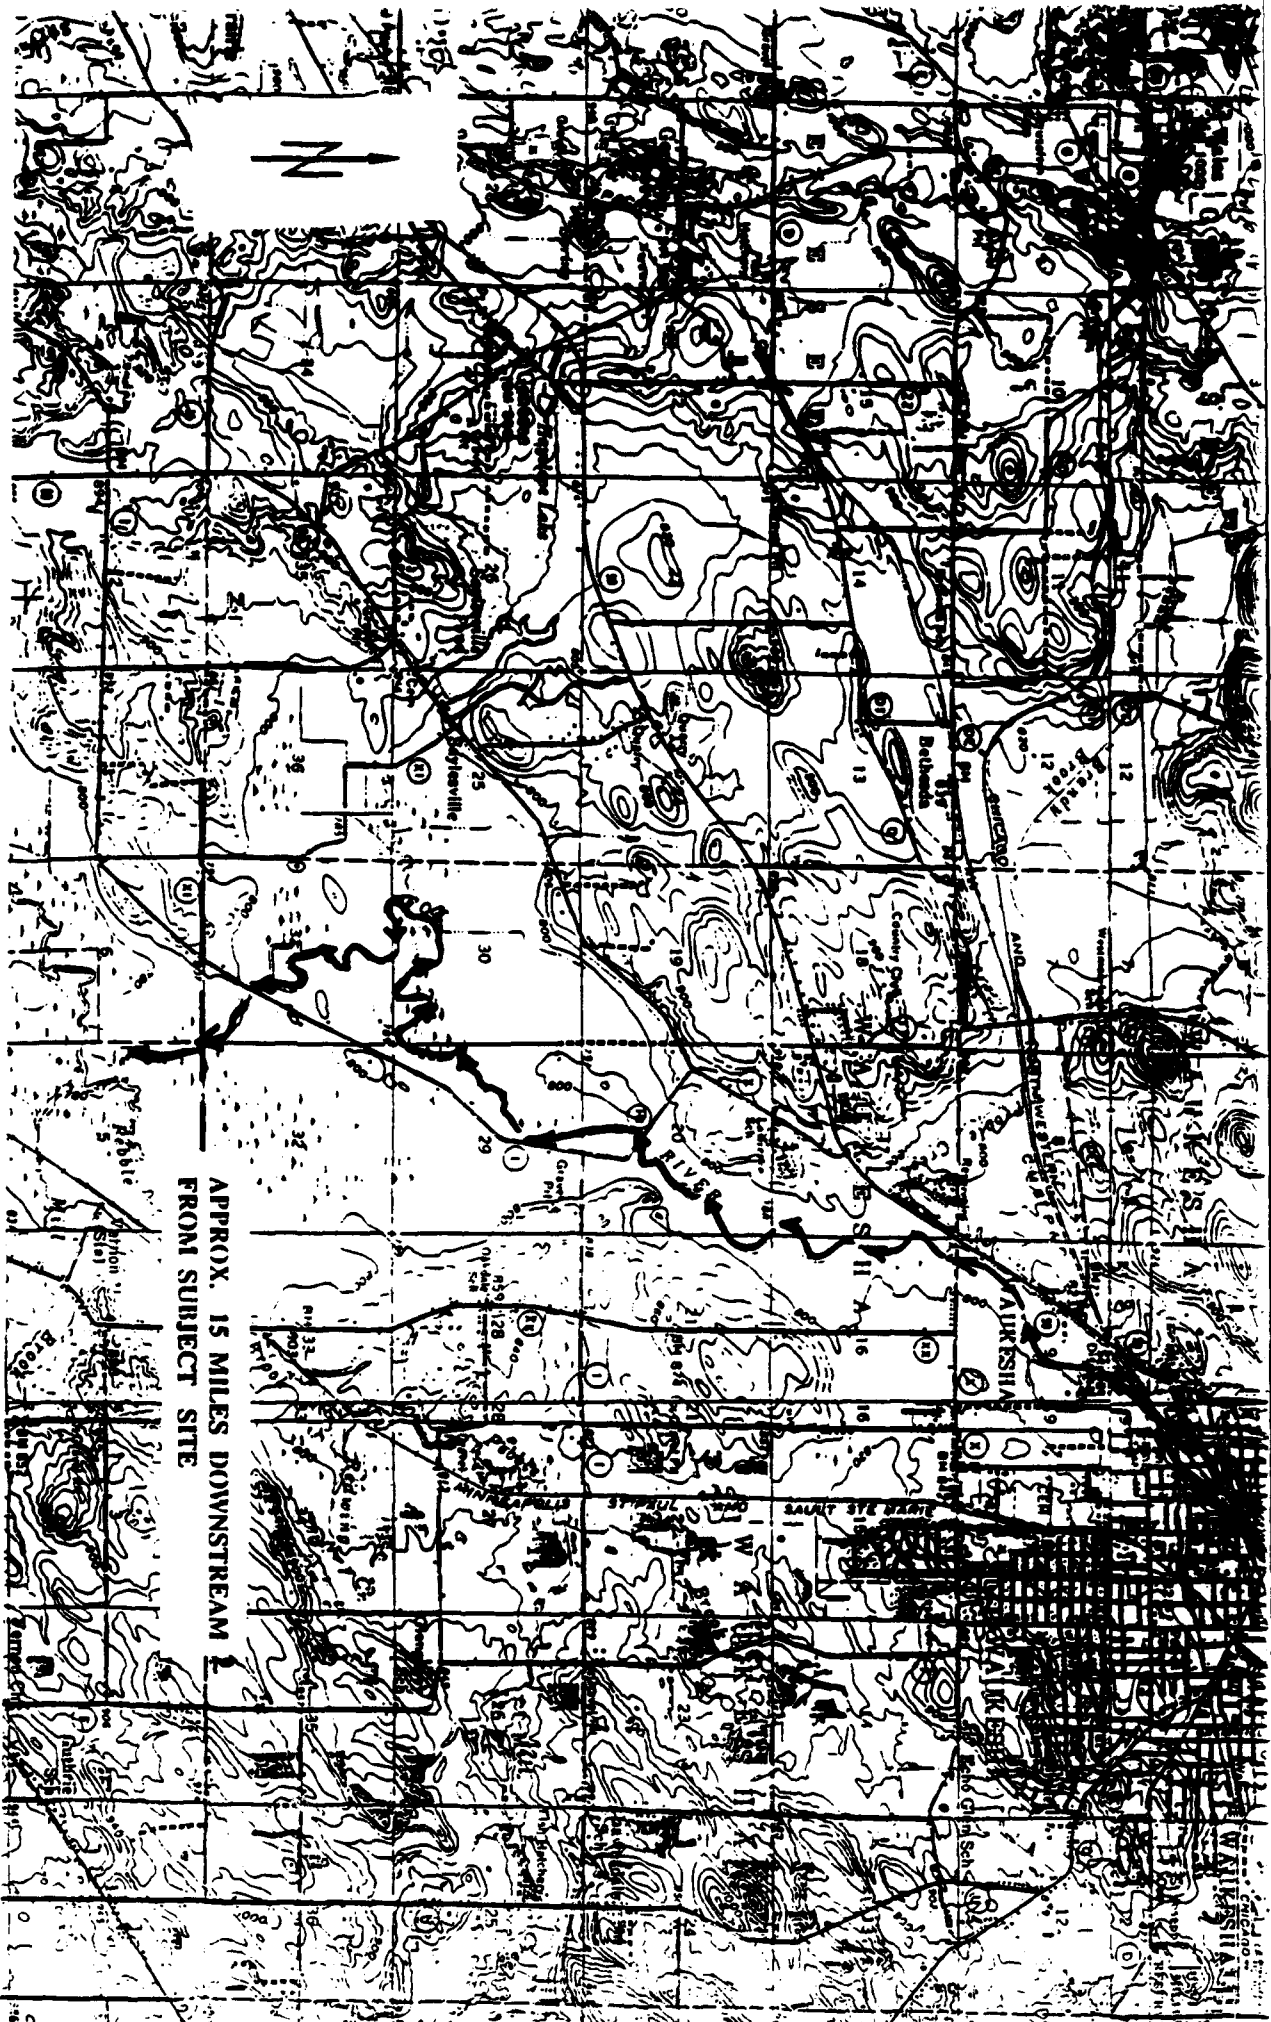
Figure 6 - SURFACE WATER MIGRATION PATHWAY

There has been no indication or report of contaminants to the surface waters from the site. The drainage ditch located to the west side of the property shows no signs of damaged vegetation, discoloration, or oil sheens. There are no drinking water intakes located within fifteen downstream miles. There are three human food chain targets located within fifteen downstream miles of the site. Human food chain targets are any surface water body from which fish or other water animals are taken or could be taken for human consumption. They are the Pewaukee Lake, the Pewaukee River, and the Fox River. The flow in the Pewaukee River is not monitored.

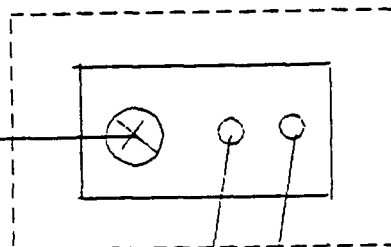
Tank was surrounded by
asphalt, except for an
opening enabling access
to the tank.

Soil Sample Location For
TPH Analysis

Vent Line

Fill Pipe

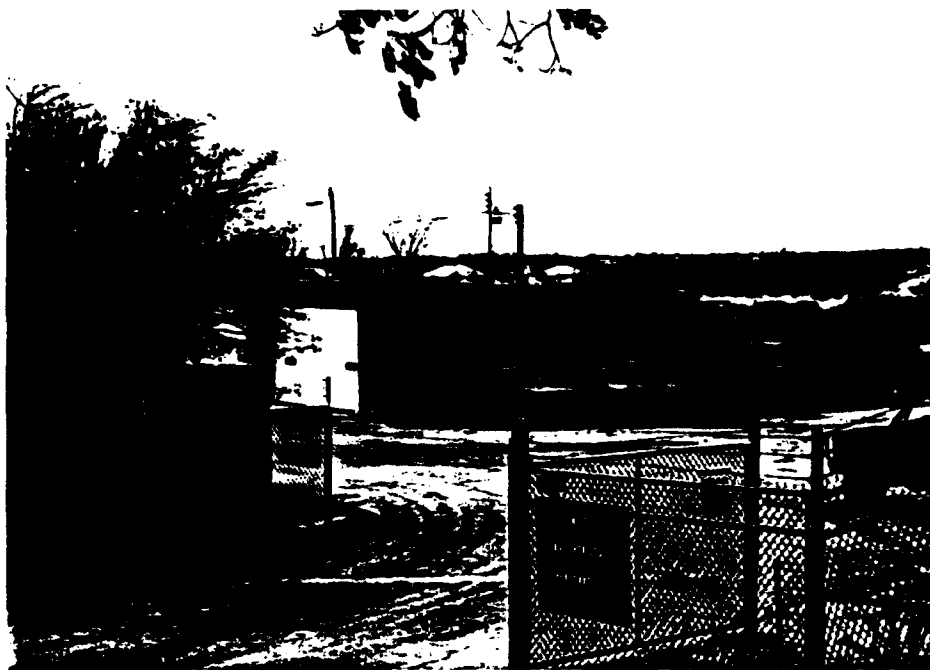
PHOTO 7 - LOOKING NORTHWEST AT THE MAINTENANCE FACILITY

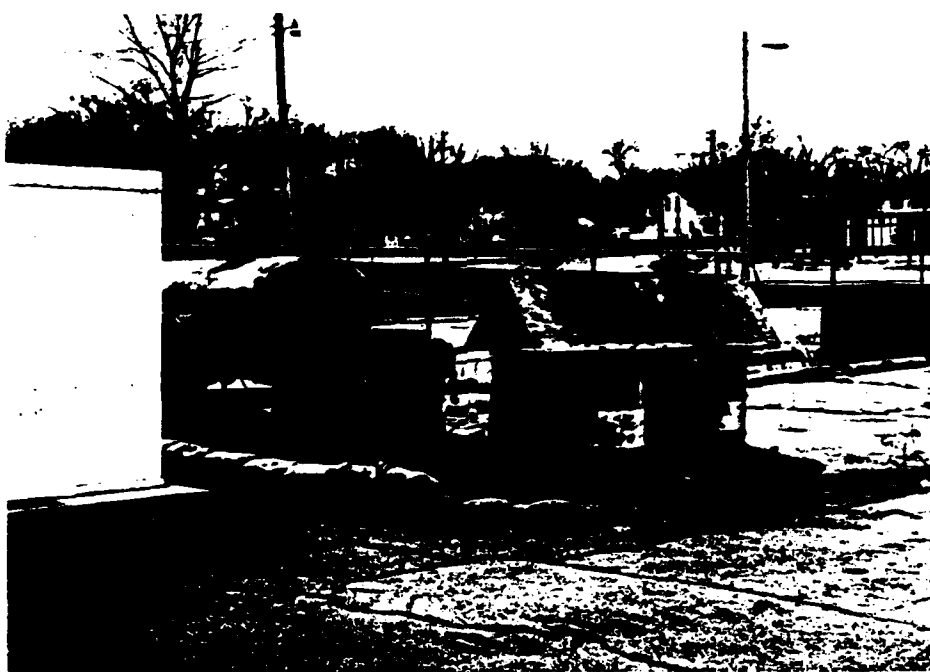
The on-site waste source types can be described as drums, tanks, and storage room. The drums consist of the one 55-gallon drum, which contains used oil, located in the Vehicle Maintenance Shop; and four 55-gallon drums, containing a combination of

oil, solvents, antifreeze and water. The tanks consist of one 400-gallon mobile storage tank, containing used oil and water; and two No. 2 heating oil USTs, one 1,000-gallon and one 6,000-gallon. The two USTs were removed in 1992. The paint storage room contains paints, varnish, and corrosion preventative. These materials are stored in gallon and quart size containers; the quantity varies.

PHOTO 8 - LOOKING SOUTHWEST AT THE 400-GALLON MOBILE STORAGE TANK AND THE FOUR 55-GALLON STORAGE DRUMS

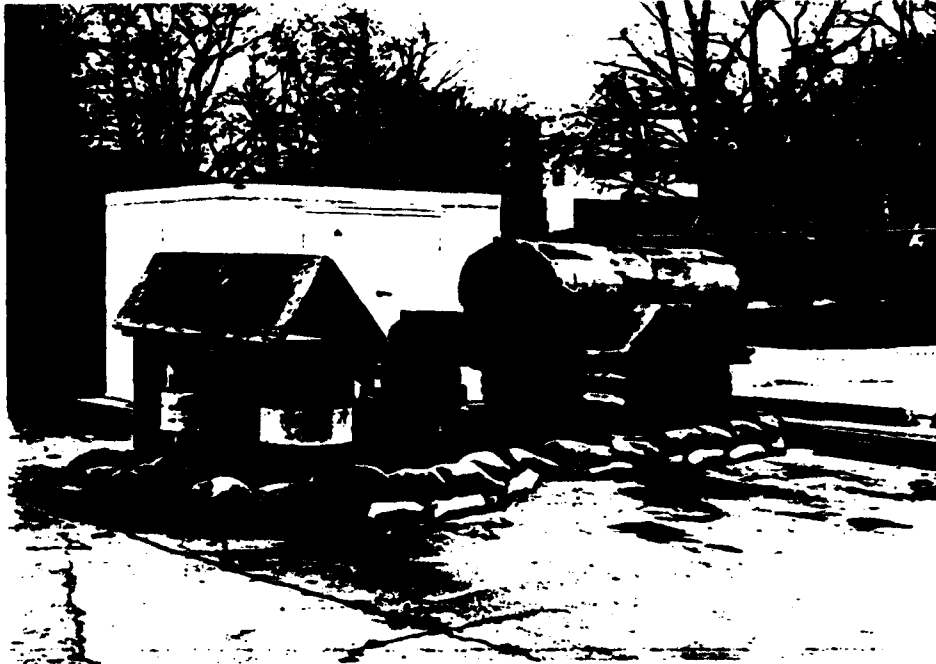
PHOTO 9 - LOOKING SOUTHEAST AT THE 400-GALLON MOBILE STORAGE TANK AND THE FOUR 55-GALLON STORAGE DRUMS

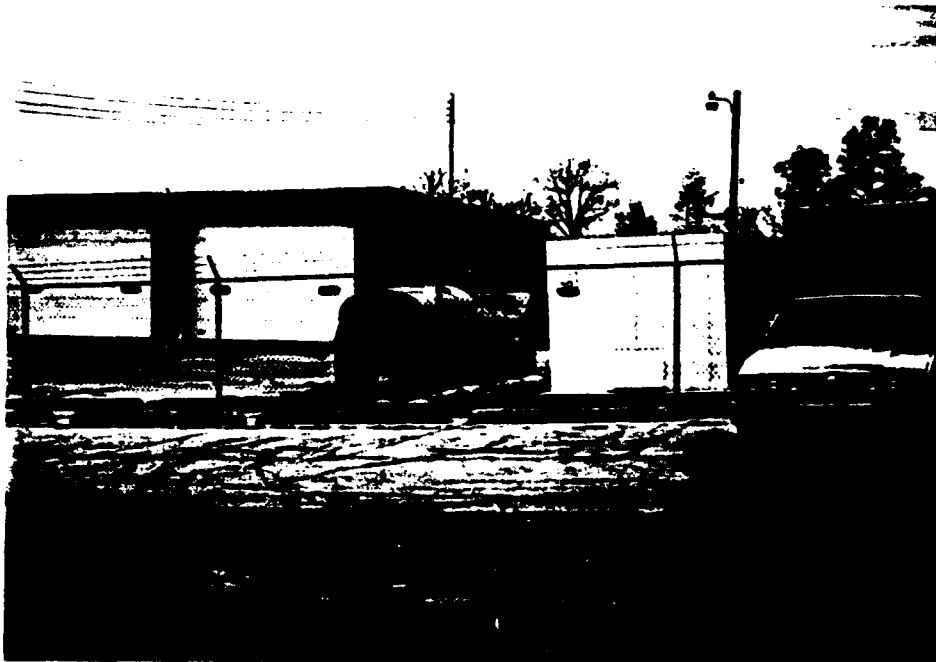
PHOTO 10 - LOOKING NORTH AT THE 400-GALLON MOBILE STORAGE TANK
